Pipeline Integrity Program Update

Board Committee
September 28, 2021

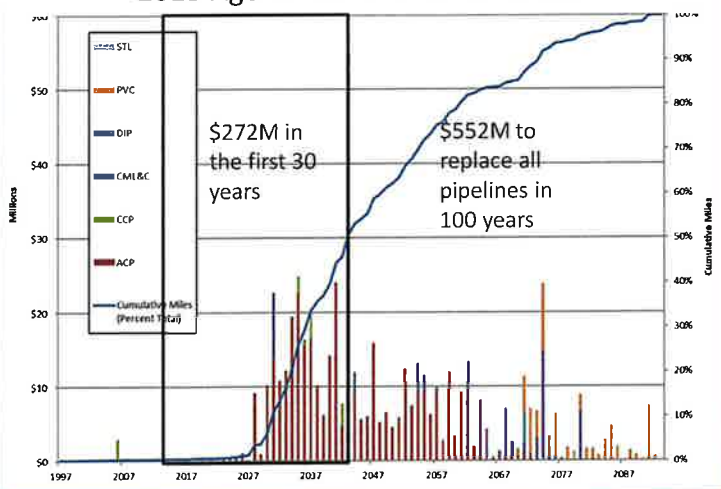
2013 Age-Based Renewal Forecast

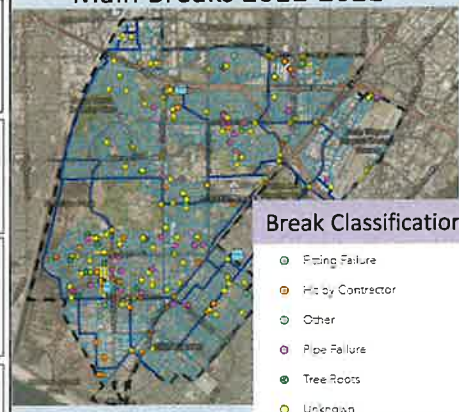
Main Breaks 2011-2021

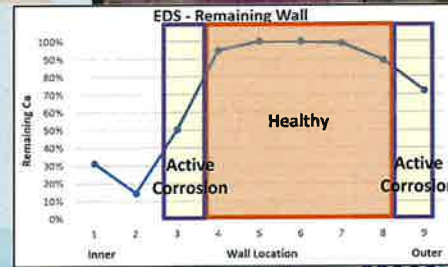
Exposed Pipe Testing FY 20-21

- 13 AC Pipe Samples collected during valve replacements
- Walk thickness measurements using stain test and EDS
- Remaining useful life for FY 20-21 samples is 77 years.

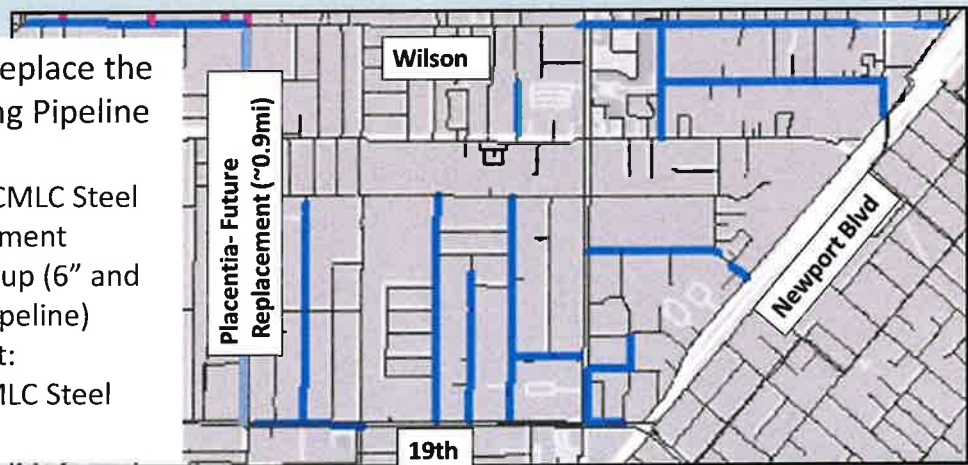
CIPR Projects to Replace the Poorest Performing Pipeline Cohort Group:

- Wilson Ave 12" CMLC Steel Pipeline Replacement
- 1951 Cohort Group (6" and 8" CMLC Steel Pipeline)

- 14" Placentia CMLC Steel Pipeline
